COMMUNICATIONS AND TRACKING SUBSYSTEM APPROACH AND LANDING TEST PHASE TASK 501 RF PATH CONSOLE ACCEPTANCE TEST REPORT

Job Order 17-069

May 1976

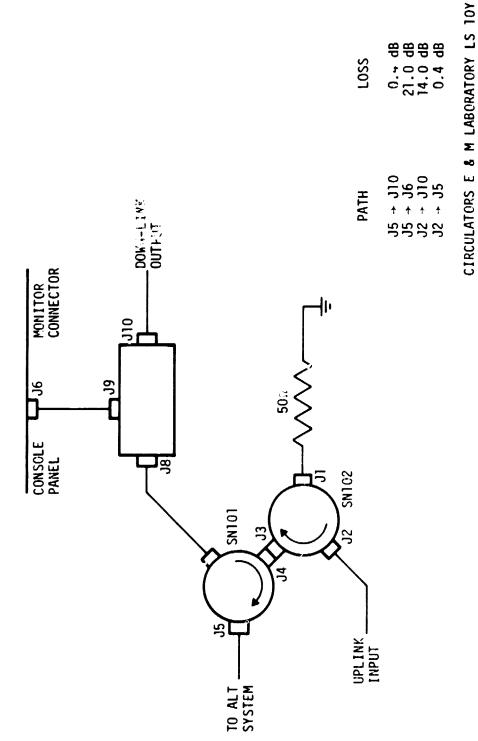
Figure 1. - S-Band RF path data.

The loss in the S-band RF path for the direct signal was approximately 0.4 dB. The losses in the UHF path were 0.1 dB or less. Each path provided a monitor point. The nominal attenuation for each monitor point is 20 dB. The measured values were within a fraction of a decibel of the nominal attenuation. There were no losses above the nominal tolerance and expected values. The cables and connectors have been shown to be satisfactory.
